# SPIRAL CABLE

## REMOVAL

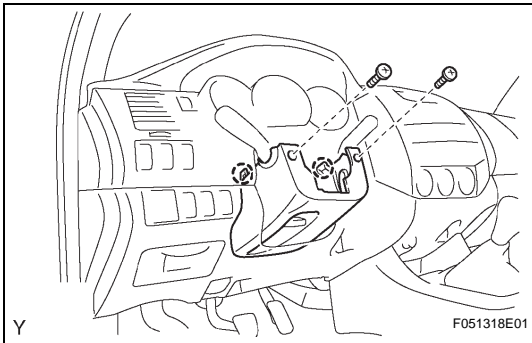
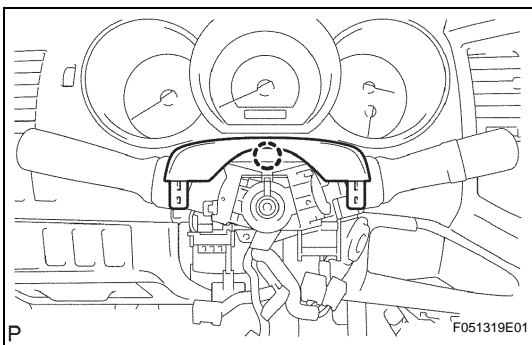
1. **PRECAUTION**
2. **DISCONNECT CABLE FROM NEGATIVE BATTERY TERMINAL**  
Wait for at least 90 seconds after disconnecting the cable to prevent the airbag from working.
3. **PLACE FRONT WHEELS FACING STRAIGHT AHEAD**
4. **REMOVE NO.2 LOWER STEERING WHEEL COVER**  
(See page [SR-9](#))
5. **REMOVE NO.3 LOWER STEERING WHEEL COVER**  
(See page [SR-9](#))
6. **REMOVE STEERING PAD** (See page [RS-558](#))
7. **REMOVE STEERING WHEEL ASSEMBLY** (See page [SR-9](#))
8. **REMOVE LOWER STEERING COLUMN COVER**
  - (a) Remove the 2 screws.
  - (b) Disengage the 2 claws to remove the steering column cover lower.
